REUBENS BUILDING AND INSPECTIONS

RESIDENTIAL REPORT

85 Copperfield St, Geebung
4034

JANUARY 14, 2019

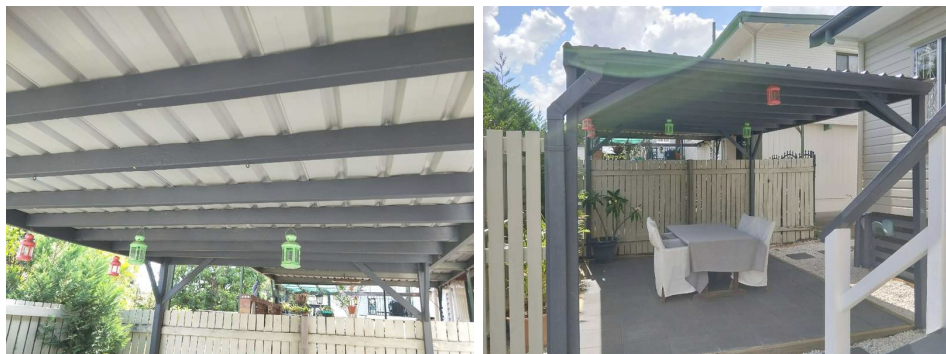
2.3.2 Decks, Balconies, Porches & Steps

TIMBER OVERSPAN

Contact a qualified professional.

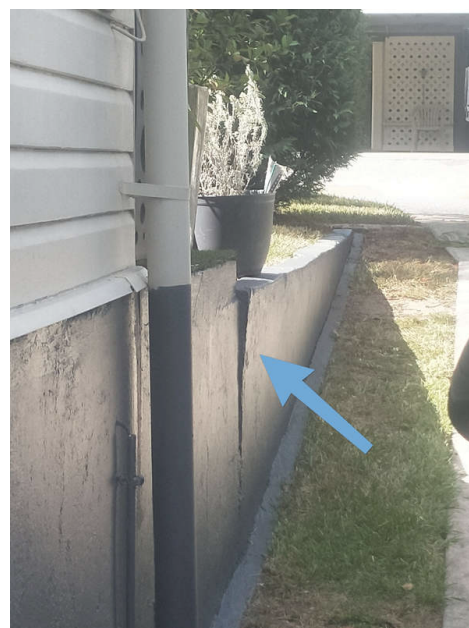
2.4.2 Fence, Drainage & Retaining Walls

RETAINING WALL - IS OUT OF VERTICAL PLUMB AND APPEARS TO HAVE BEEN MAINTAINED IN THIS STATE FOR SOME TIME AND IS CONSIDERED NOT TO BE ANY IMMEDIATE THREAT, KEEP MAINTAINED

Recommended DIY Project
